Imagery Analysis Report

Failure of San-men Gorge Reservoir Project, China

FAILURE OF SAN-MEN GORGE RESERVOIR PROJECT, CHINA

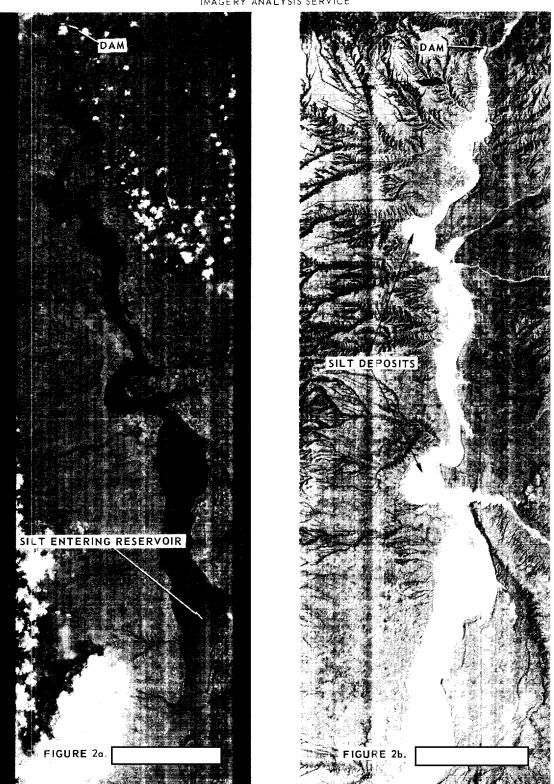
FIGURE 2. SAN-MEN GORGE RESERVOIR

The San-men Gorge Reservoir is situated in a deep canyon on the middle reaches of the Yellow River (Figure 2a). When filled, the reservoir extends 55 nautical miles (nm) upstream from the dam at San-men Gorge to the confluence of the Yellow and Wei Rivers. The reservoir dam is reported to be 350 feet high and is approximately 3,000 feet long. Its capacity is reported to be over 28 million acre feet.

Photography revealed that the reservoir was partially filled. The tone of the water entering the reservoir indicated that it was carrying a large amount of silt (Figure 2a), and the volume of water in the river downstream from the dam appeared to have been reduced.

During all of the sluice gates were open, the reservoir was empty, and large deposits of silt were visible in the reservoir (Figures 2b and 3). Later photography revealed that all of the sluice gates continued to be left open, and the reservoir was still empty.

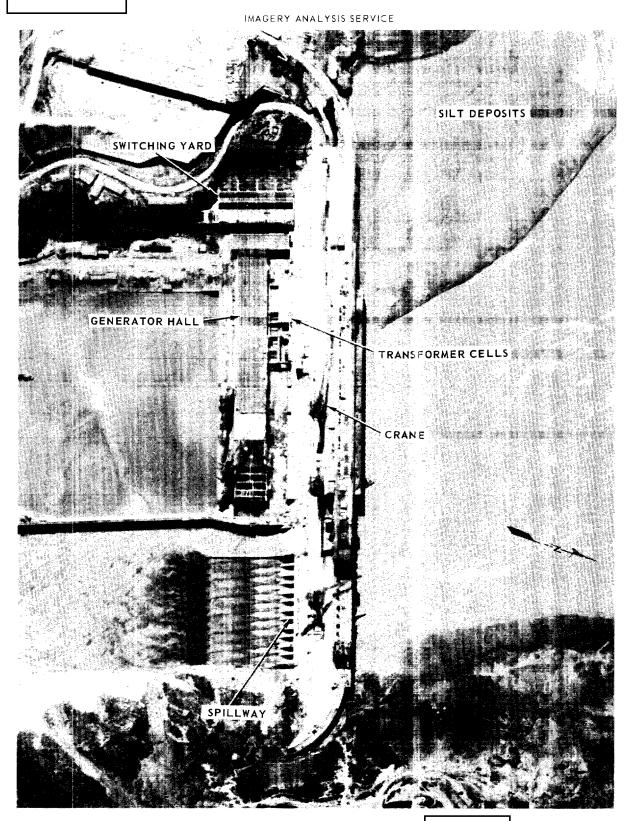
FIGURE 4. SAN-MEN HYDROELECTRIC DAM.

The external features of the hydroelectric power plant associated with the dam at San-men appeared to be in the late stages of construction on photography $\overline{}$ (Figure 4). At this time all of the cofferdams and the construction equipment that had been located on the river floor were removed. The switching facility, substation, and transmission lines were nearing completion and the last of eight turbogererator sections was being roofed; however, it was not possible to determine the number of turbines or generators that had been installed. Covered transformer cells (two per turbogenerator) were being constructed between the generator hall and dam; six of the cells were under construction. More recent photo coverage of indicated that the power house was completely roofed, and that only three of the transformer $\epsilon\epsilon$ lls had been covered. The switching facility at the western end of the generator hall appeared to be completed with eight sets of switch gear installed. A cantilever crane was still located on the roof of the power house, and a traveling support tower with aerial cable-way was still present. On photography three burbine housing outlets were discharging water; cal photography Cour outlets were discharging. The spillway has been in operation on all photographic coverage. Since no head of water has formed the discharge from turbine housing outlets observed were from turbogenerator sections where transformer cells had not been completed, it is probable that the power plant was not in operation.

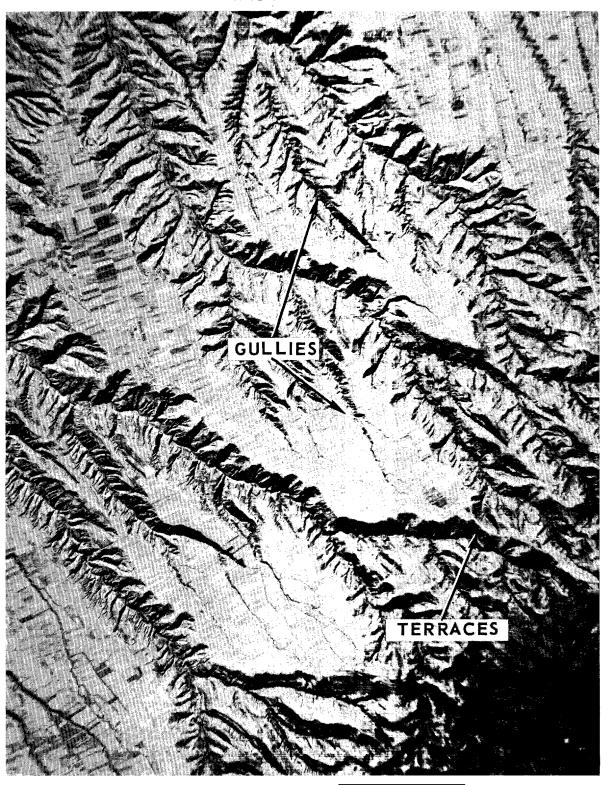
FIGURE 5. ERODED LOESS,

The Loess Plateau is an old dissected peneplain which has been covered by a layer of wind deposited dust varying from a few feet to over 250 feet thick. This light unconsolidated loess is commonly overtilled, and without its natural vegetation cover and under the influence of heavy summer downpours, is extremely susceptible to erosion. Photography reveals (Figure 5) that natural vegetation covers less than five percent of the plateau, and that gully and sheet erosion occur over a large portion of the drainage area. With 65 percent of the total annual rainfall occurring in July, August, and September (Table 1), usually as heavy downpours, tremendous quantities of silt are being washed into the Yellow River.

The immediate task to reduce erosion in a watershed usually is to recreate the natural vegetation by aforestation and grass planting. Recent photography indicates that the Chinese have accomplished very little toward this first step of erosion control nor have they begun construction of silt control dams on the Yellow River and its important tributaries.

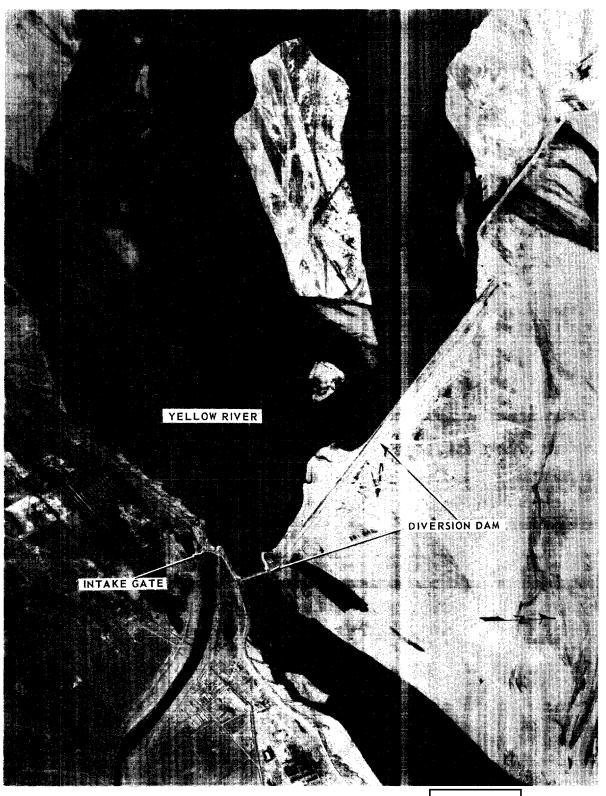
FIGURE 6. CHENG-CHOU CANAL INTAKE GATE,

Photography Chinese are having difficulty in obtaining a sufficient supply of water for the Cheng-chou and Lan-feng Irrigation Projects (Figures 6 and 8) located 130 and 210 nautical miles downstream from the dam. During this five year period the canal intake gates were photographed in both the wet and dry seasons, times when the river would normally be at its highest and lowest Levels. Dates when the water was above or below the intake gates are given in Table 2. This table includes all available coverage from the date the Since there is insufficient photographic dam was closed coverage of the canal intake gates before the dam was closed, the extent of retrogression cannot be determined. It is evident, however, that only a small amount of water for irrigation is available during the wet season and that even less water is available during the winter wheat growing season of March, April, and May when evaporation generally exceeds rainfall in these irrigation projects. In addition, during the wet season of 1965, flood waters destroyed the major portion of the Cheng-chou Diversionary Dam located at 34-55N 113-36E (Figures 6 and 7). This further complicates the tesk of obtaining sufficient water for the Cheng-chou Irrigation project.
